# **Xerox® VersaLink® B7025/B7030/B7035**

## **Multifunction Printer**

### **Service Manual**

708P91369

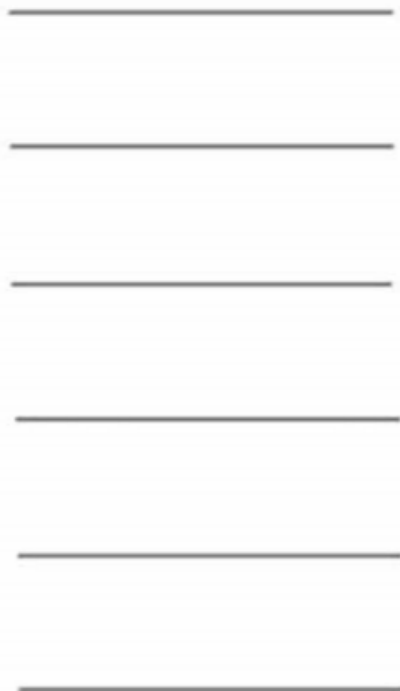
Y-1-0426-A

Regular pitch toner contamination in the process direction. Refer to [Figure 1](#).

Figure 1 Example

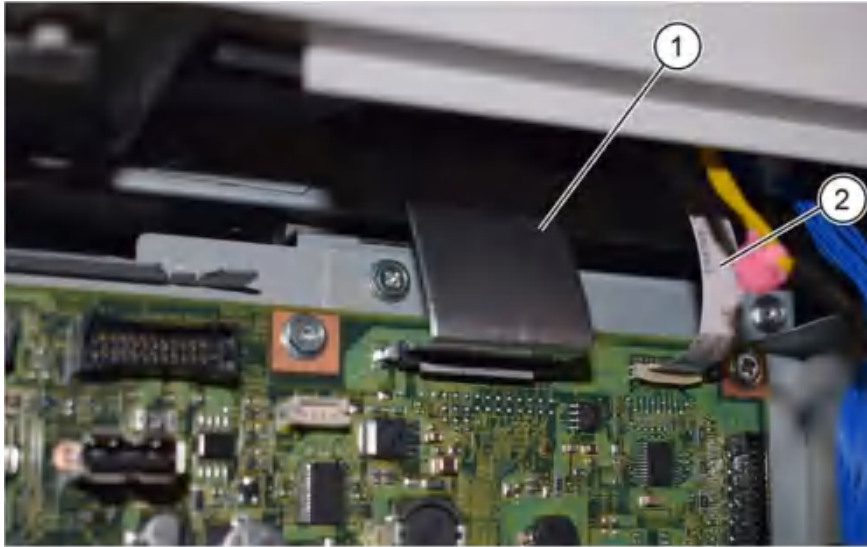
Y-1-0026-A

*The FFC LED cable is secured by a clamp. Carefully lift both ends of the cable clamp simultaneously to release the cable.*

11. Carefully disconnect the CCD ribbon cable (1) and the FFC LED cable (2), [Figure 10](#).

Figure 10 Cables

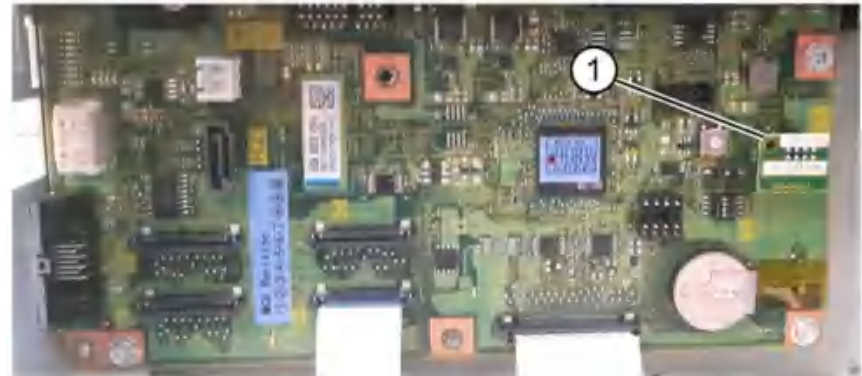
Y-1-0029-A

*Take care when removing and reinstalling the SEEPROM. The pins are easily damaged.*

- a. Remove the SEEPROM (1) from the old ESS PWB, then install it onto the new ESS PWB, **Figure 13**.

**Figure 13 SEEPROM**

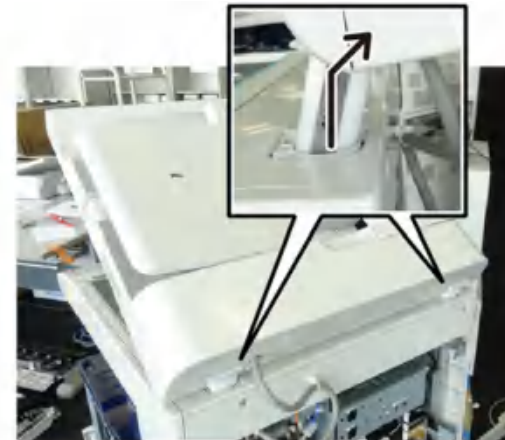
4. Remove the DADF, [Figure 2](#).

Figure 2 DADF removal

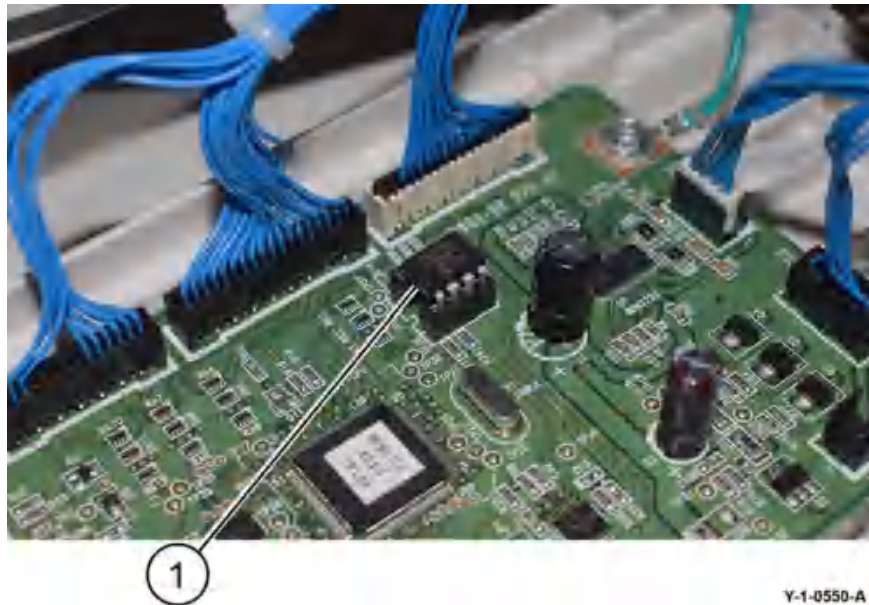
*Take care when removing and reinstalling the SEEPROM. The pins are easily damaged.*

- Remove the SEEPROM (1) from the old DADF PWB, then install it onto the new DADF PWB, [Figure 4](#).

**Figure 4 SEEPROM**

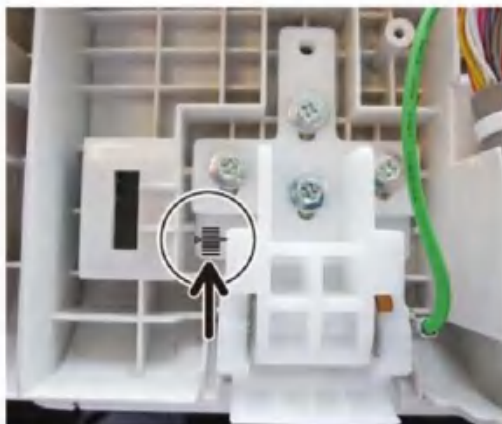
1. Remove the DADF rear cover, [REP 5.4](#).
2. Remove the DADF, [REP 5.1](#).
3. Record the position of right counter balance, [Figure 1](#).

Figure 1 Position

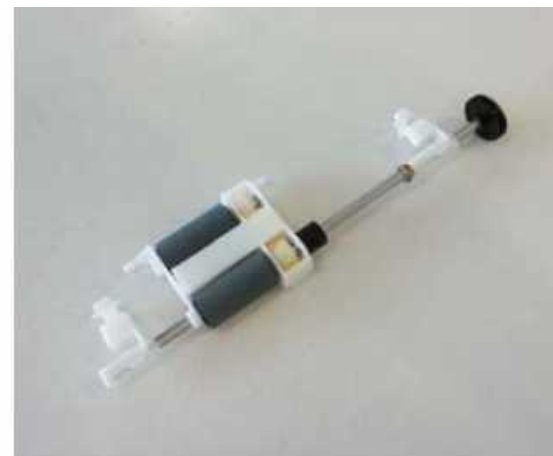
**NOTE:** The removed feed/nudger roll assembly is shown in Figure 2.

Figure 2 Removed feed/nudger roll assembly

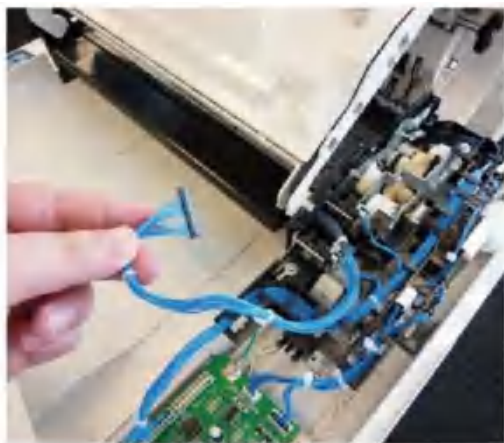
**NOTE:** The removed harness is shown in [Figure 2](#).

**Figure 2** Removed harness

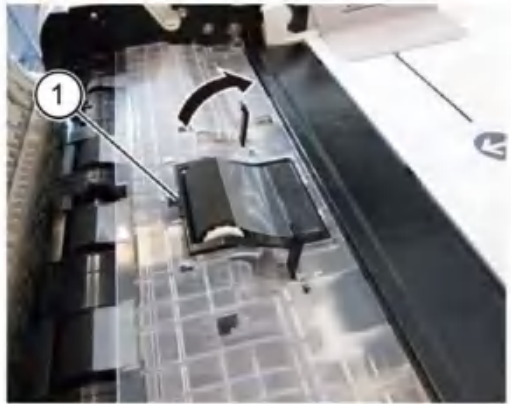
Figure 1 Retard CRU cover assembly

1. Open the upper feeder assembly.
2. Release the hook (1), then open the retard CRU cover assembly in the direction of the arrow, [Figure 1](#).

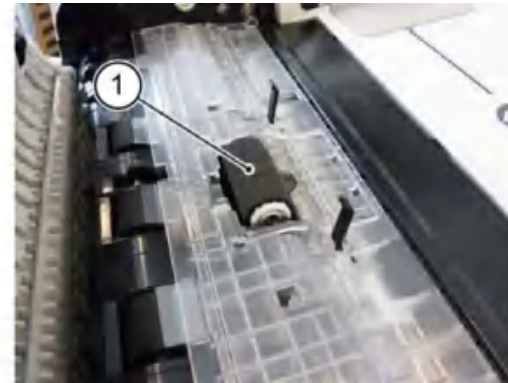
Figure 2 Retard roll assembly removal

3. Remove the retard roll assembly (1), [Figure 2](#).

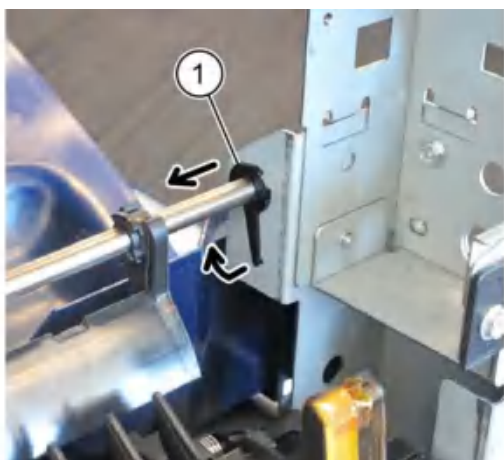
Figure 1 Bearing

1. Remove the exit 2 transport assembly, refer to [REP 10.2](#).
2. Remove the exit front cover, [PL 28.05 Item 10](#).
3. Remove the fusing fan duct assembly, [REP 10.4](#).
4. Move the bearing (1) toward the front, [Figure 1](#).

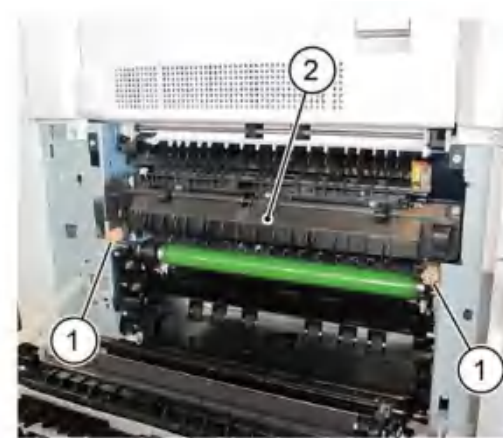
Figure 1 Fuser removal

1. Open the LH transport assembly.
2. Remove the fuser, [Figure 1](#):
  - a. Loosen two screws (1).
  - b. Remove the fuser(2).

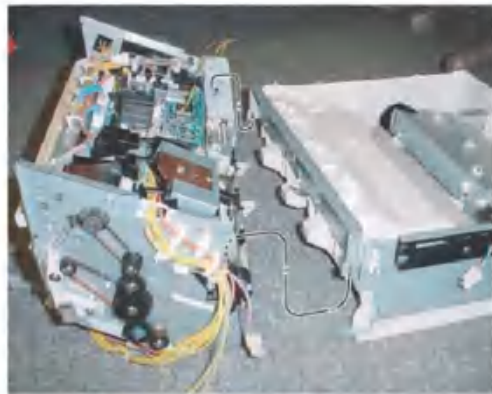
1. The replacement is the reverse of the removal procedure.
2. Install the stacker tray assembly and integrated office finisher as shown in Figure 5.

Figure 5 Stacker tray assembly installation

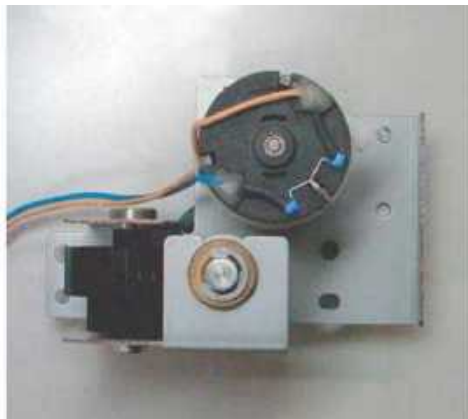
Figure 5 Stacker motor installation

- The replacement is the reverse of the removal procedure.
- Install the stacker motor as shown in Figure 5.

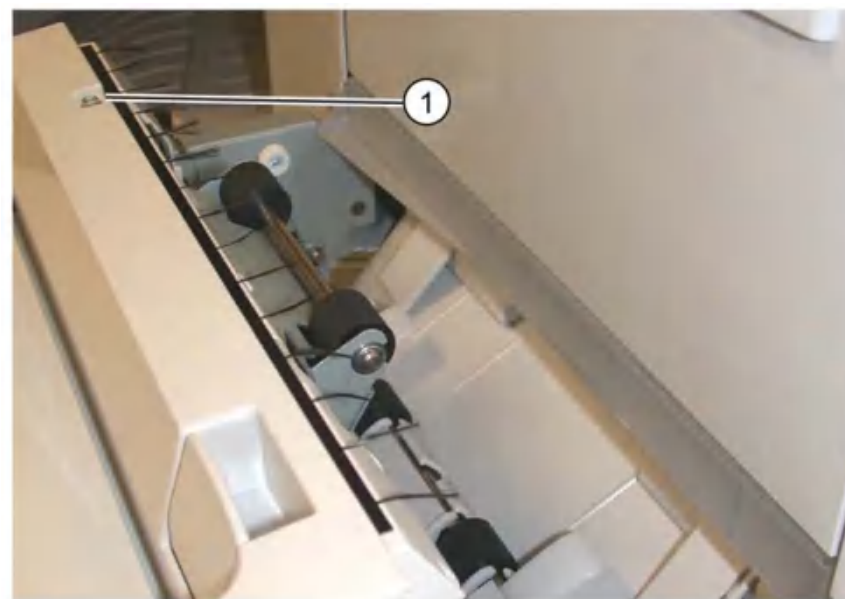
Y-1-0352-A

5. Install the retaining screw (1), [Figure 6](#).

**Figure 6 Retaining screw**

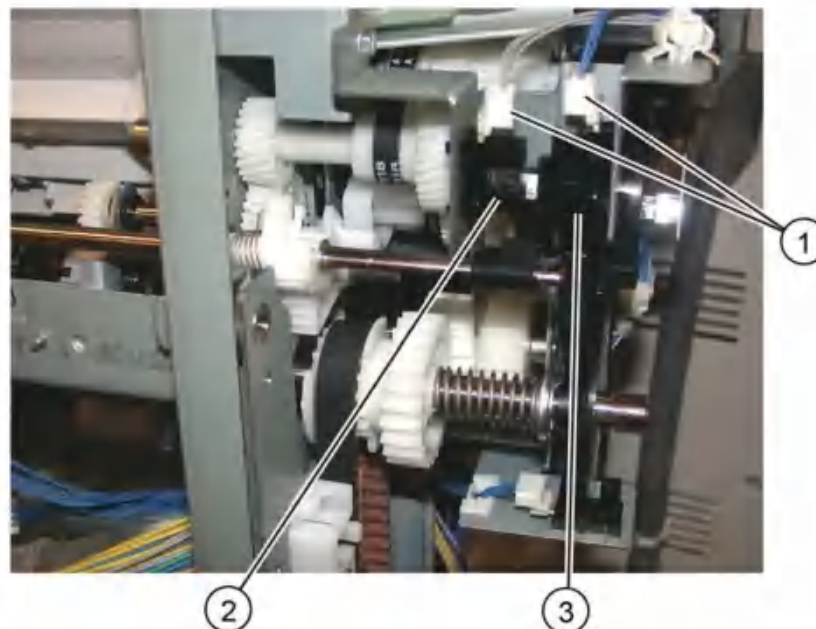
1. Remove the rear upper cover, [REP 13.7](#).
2. Remove the relevant stack height sensor, [Figure 1](#):
  - a. Disconnect the relevant connector (1).
  - b. Remove either stack height sensor 1 (2) or stack height sensor 2 (3).

Figure 1 Sensor removal

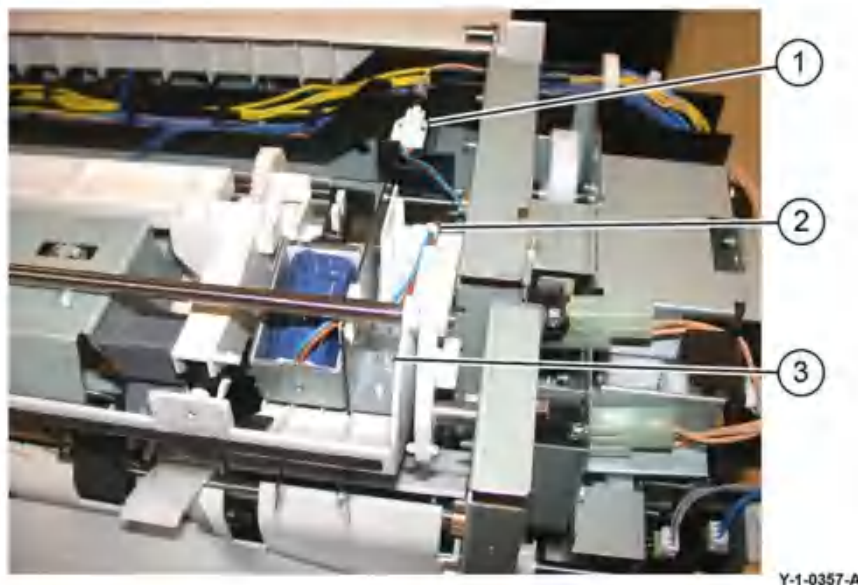
1. Remove the eject cover, [REP 13.9](#).
2. Remove the sub paddle solenoid assembly, [Figure 1](#):
  - a. Disconnect the connector (1).
  - b. Release the harness from the clamps (2).
  - c. Remove the screw (3), then the sub paddle solenoid assembly.

Figure 1 Sub paddle solenoid assembly removal

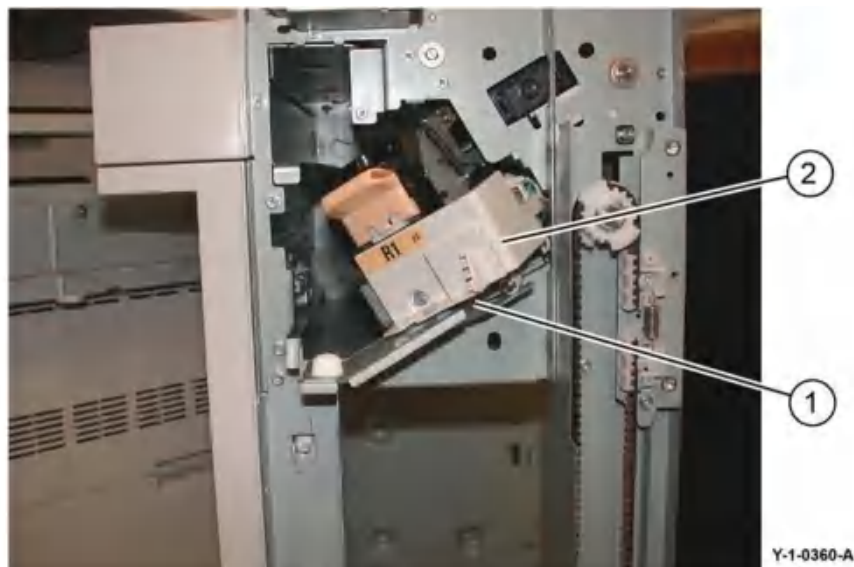
1. Remove the creaser knife assembly, [REP 13.18](#).
2. Remove the front cover assembly, [REP 13.6](#).
3. Remove the stapler cover, [Figure 1](#):
  - a. Remove the screw (1).
  - b. Remove the stapler cover (2).

Figure 1 Stapler cover removal

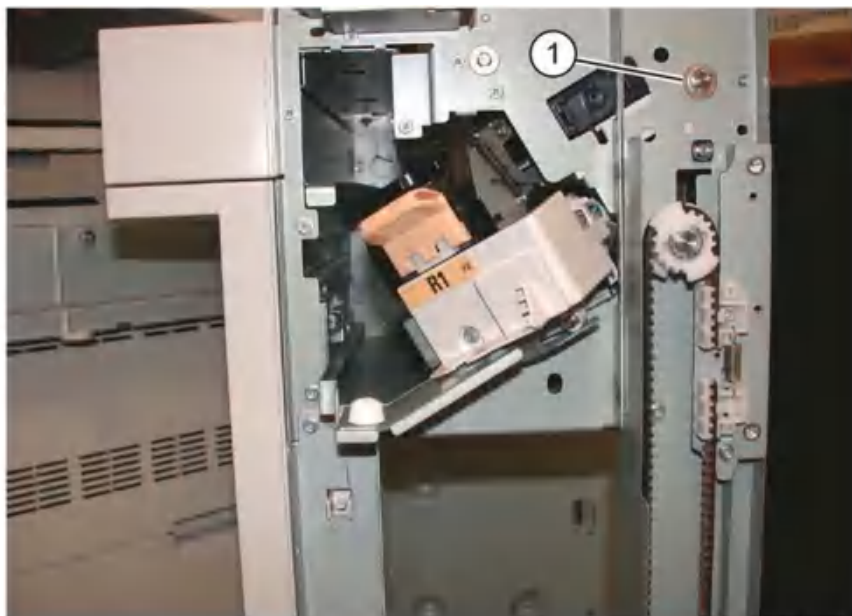
Y-1-0362-A

1. Undock the finisher, [REP 13.5](#).
2. Remove the front cover, [REP 13.6](#).
3. Remove the rear upper cover, [REP 13.7](#).
4. Remove the foot cover, [REP 13.10](#).
5. Remove the stacker lower cover, [REP 13.11](#).
6. Remove the stacker tray, [REP 13.20](#).
7. Remove the stacker upper cover, [REP 13.12](#).
8. Remove the eject cover, [REP 13.9](#).
9. Remove the E-ring and brass bearing from the front of the shaft (1), [Figure 1](#).

Figure 1 E-ring and bearing removal

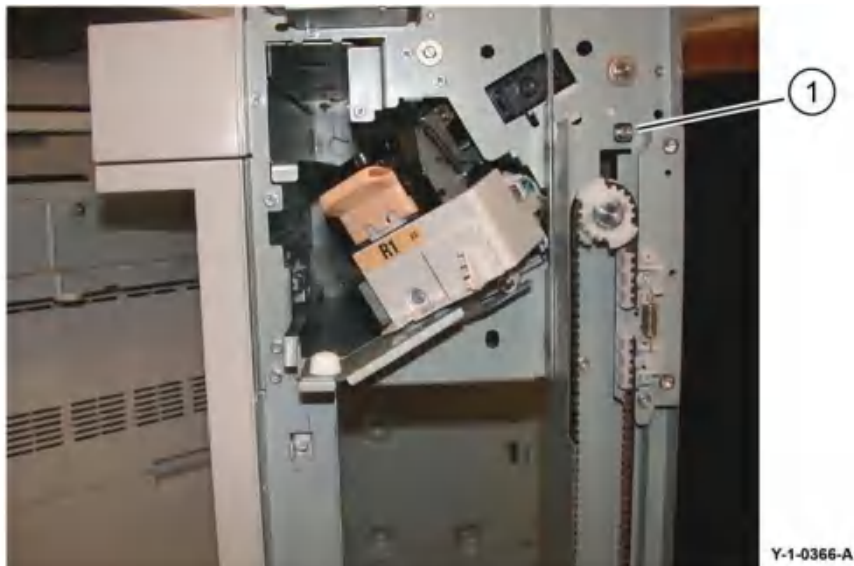
13. Remove the front E-ring and the bushing (1) from the set clamp shaft assembly, [Figure 5](#).

**Figure 5 Front E-ring removal**

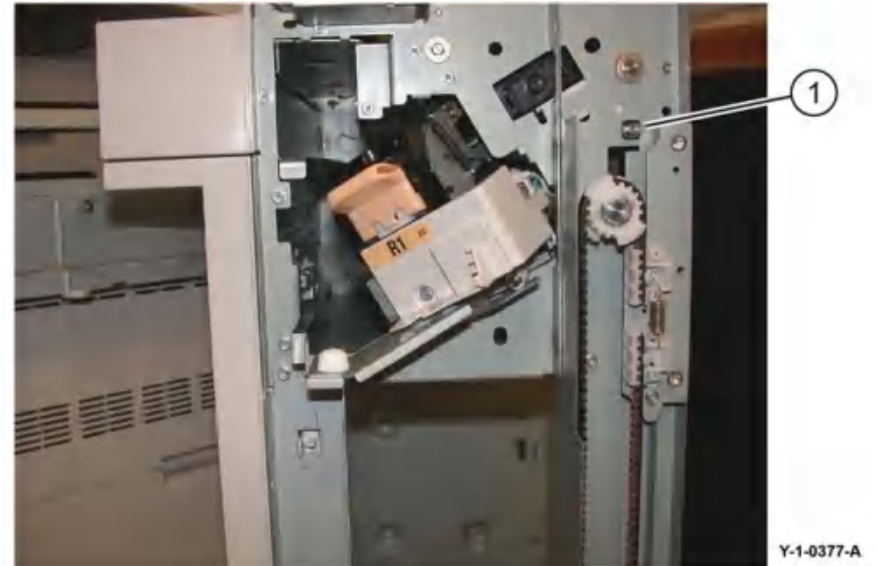
**Figure 16 Bushing and E-ring**

9. Install the bushing onto the front end of the set clamp shaft, then install the E-ring (1), [Figure 16](#).

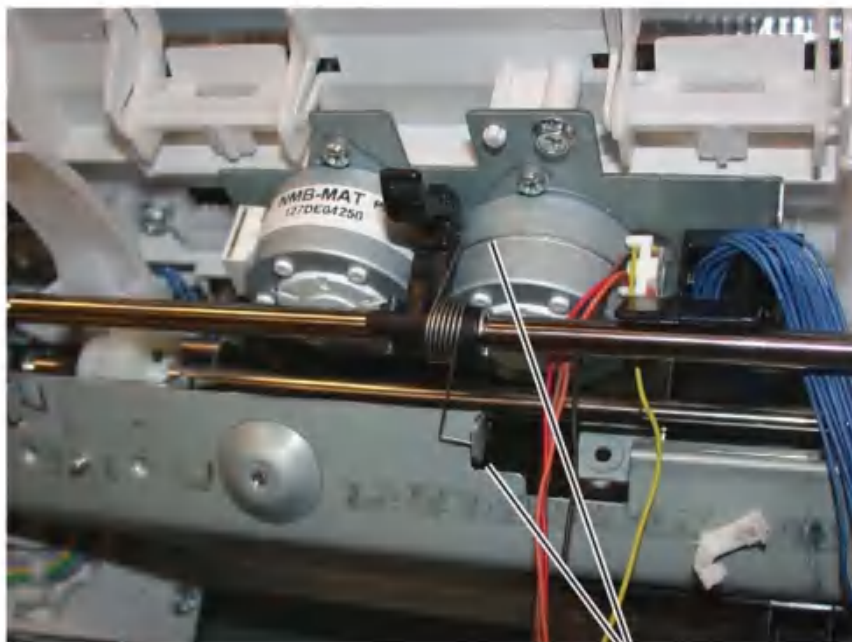
**Figure 17 Set clamp holder springs**

10. Ensure that the set clamp holder springs (1) are connected, [Figure 17](#).

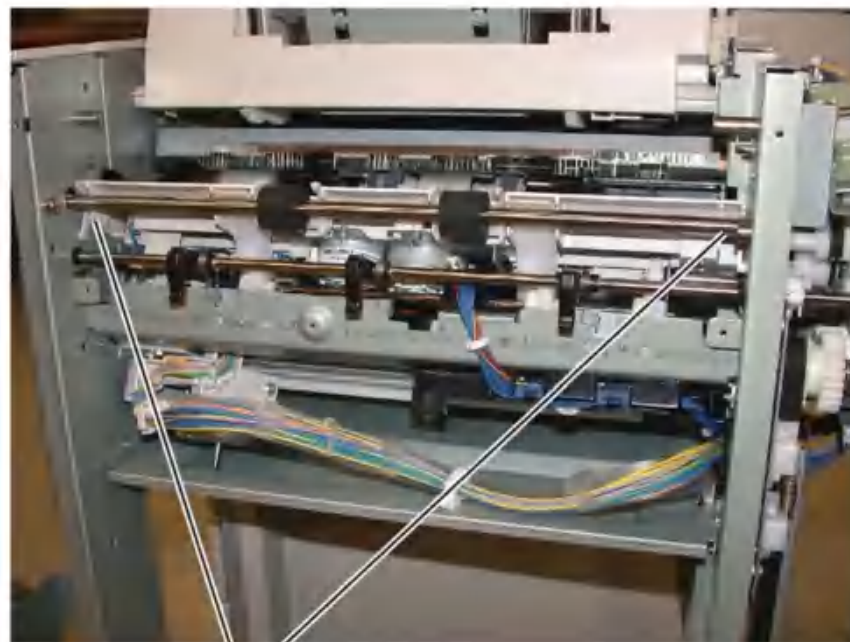
**Figure 18 Eject roll shaft installation**

11. Install the eject roll shaft (1) into position in the front and rear frame, [Figure 18](#).

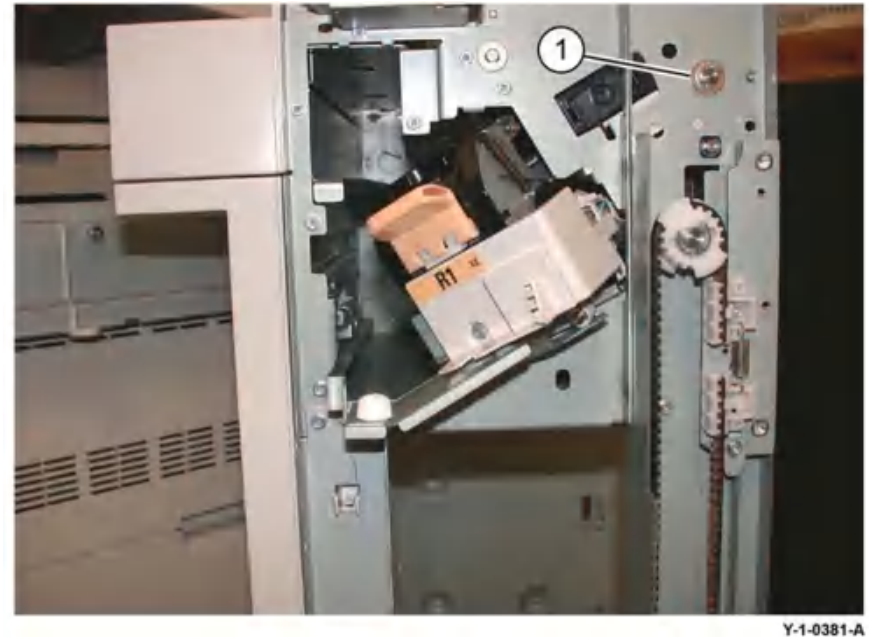
**Figure 20 Eject roll shaft front components**

13. Install the brass bearing and E-ring onto the front of the eject roll shaft (1), [Figure 20](#).

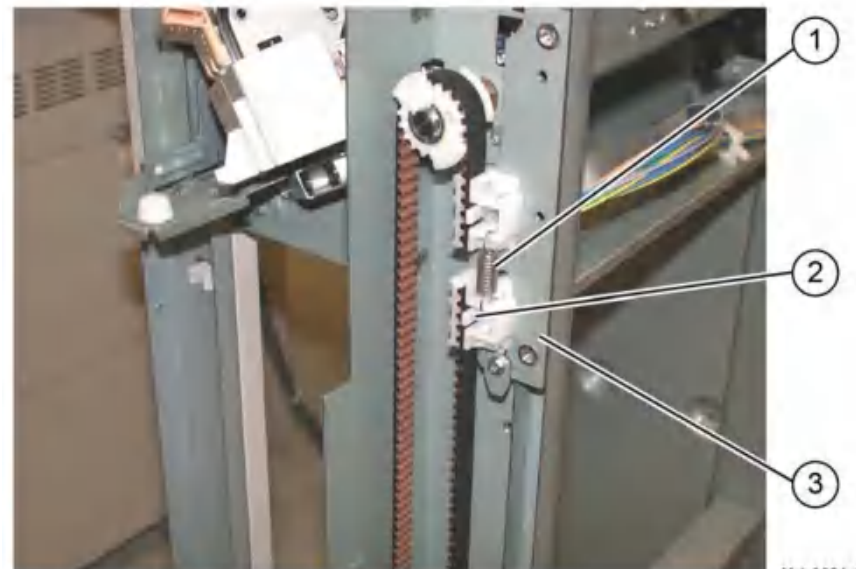
Figure 1 Carriage assembly removal

1. Enter [dC330](#), code 12-060 stacker motor up, to fully raise the stacker tray.
2. Remove the finisher front cover, [REP 13.6](#).
3. Remove the rear upper cover, [REP 13.7](#).
4. Remove the rear lower cover, [REP 13.8](#).
5. Remove the stacker tray, [REP 13.20](#).
6. Removing the carriage assembly, [Figure 1](#):
  - a. Disconnect, then remove the spring (1).
  - b. Use a flat bladed screwdriver to release the belt clamp latch (2), aside and
  - c. Remove the stacker belt and carriage assembly.

**NOTE:** The carriage bearings (2 each assembly) are not fastened to the shafts. Ensure the bearings are retained when the carriage assembly is removed.

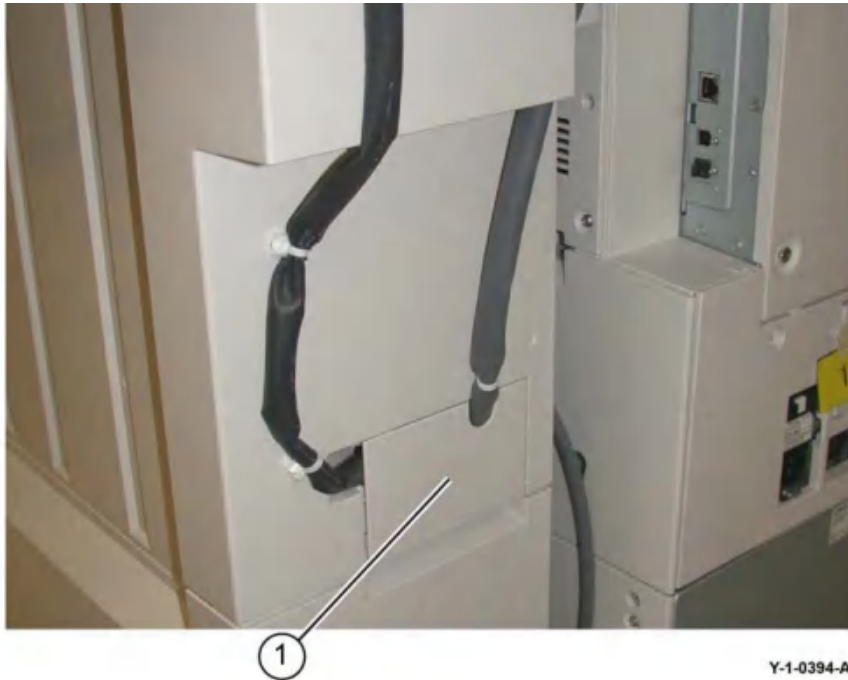
**Figure 2 Connector cover**

2. Remove the connector cover (1), [Figure 2](#).

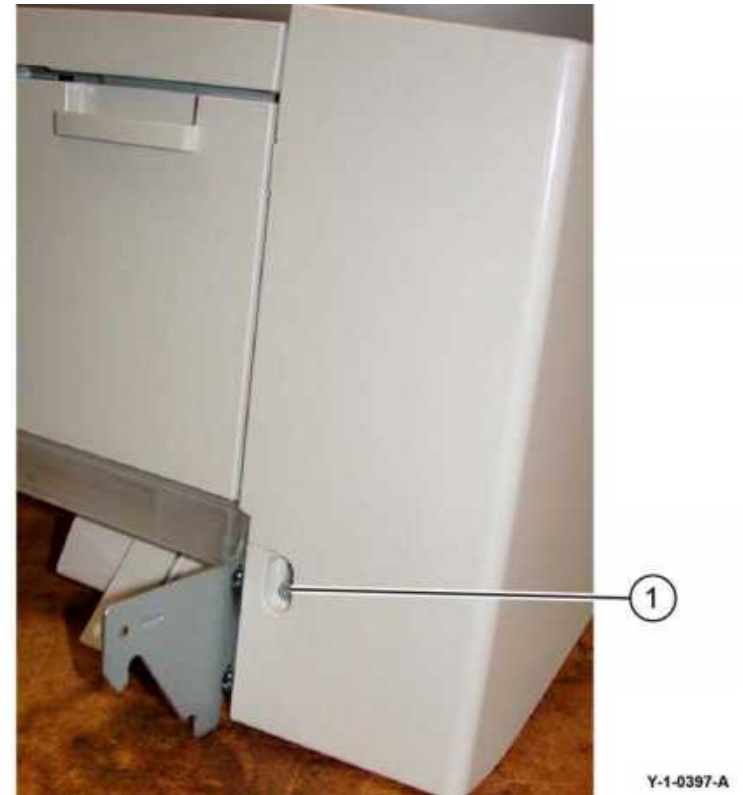
Figure 1 Screw removal

1. Remove the booklet maker assembly from the finisher, [REP 13.31](#).
2. Remove the screw (1), [Figure 1](#).

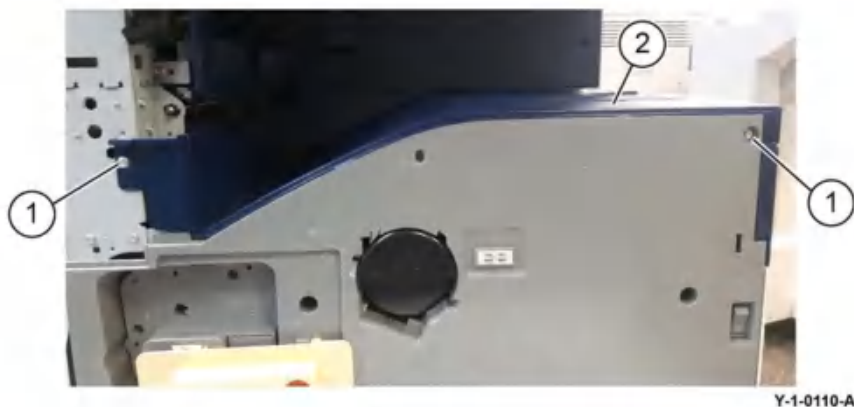
Figure 1 Top cover removal

1. As necessary, remove the:
  - Integrated finisher, REP 12.1.
  - Office finisher LX, REP 13.5.
  - Horizontal transport, REP 13.1.
2. Open the front cover.
3. Remove the pillar left cover, PL 28.05 Item 13.
4. Remove the exit front cover, PL 28.05 Item 10.
5. If an office finisher LX was installed, remove the components that follow:
  - a. Upper adjust cover, PL 13.10 Item 18 and lower adjust cover, PL 13.10 Item 19.
  - b. Docking plate, PL 13.05 Item 3.
  - c. Docking bracket, PL 13.05 Item 7.
6. Remove the top cover, Figure 1:
  - a. Remove two screws (1).
  - b. Remove the top cover (2).

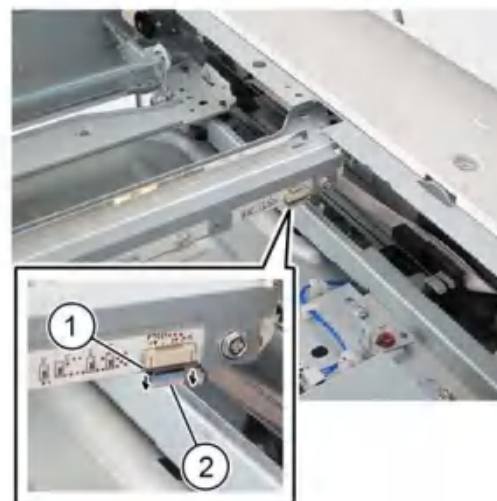
**Figure 1 FFC LED cable assembly**

1. Remove the DADF, **REP 5.1**.
2. Remove the upper rear cover, **REP 28.5**.
3. Disconnect the FFC LED cable assembly, **Figure 1**:
  - a. Move the connector housing catch (2) in the direction of the arrows.
  - b. Disconnect the FFC LED cable assembly (1).

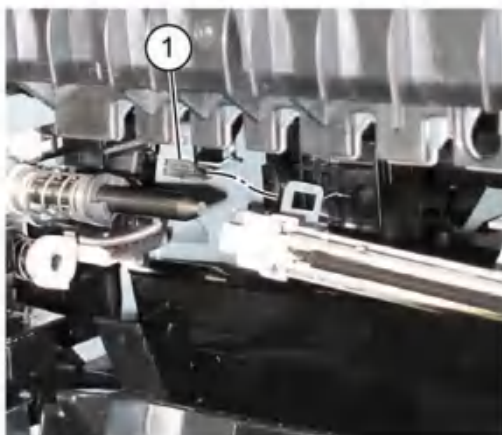
**Figure 6 Block**

1. The replacement is the reverse of the removal procedure.
2. When installing the print head assembly, fit the frame hole into the block (1), [Figure 6](#).

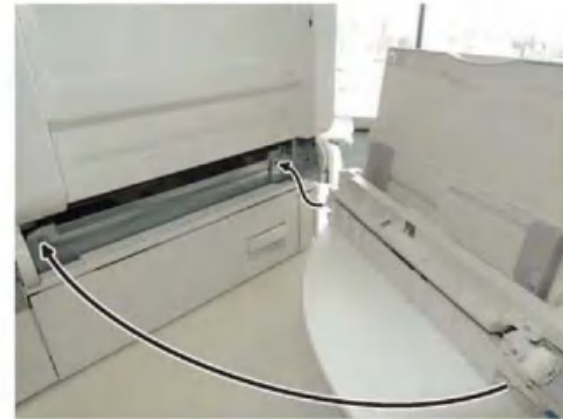
**Figure 4 Replacement**

1. The replacement is the reverse of the removal procedure.
2. When installing the bypass tray, insert the two bypass tray bosses into the holes in the frame, [Figure 4](#).

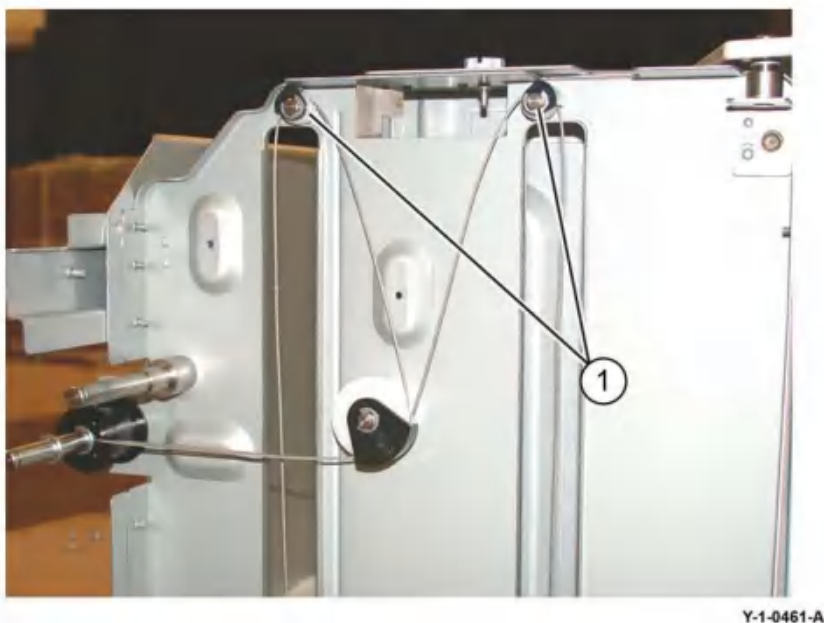
**Figure 3 Preparation**

4. Prepare to remove the tray rear cables. Remove two E-rings, wire guides and pulleys (1), [Figure 3](#).

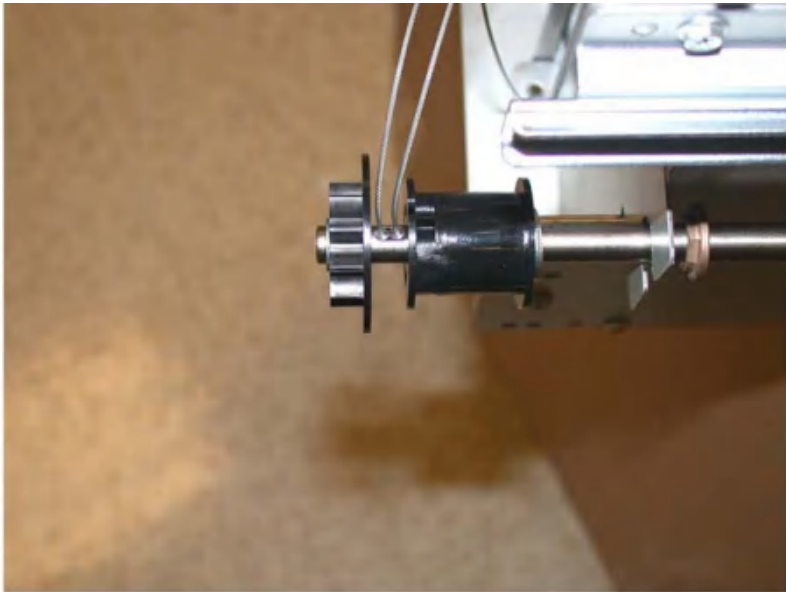
**Figure 3 Releasing the cable ends**

4. When both cables are slack, disengage the lift shaft from the frame, Then slide the tray cable pulley to the front of the lift shaft to release the rear lift cable ends that are trapped in the pocket underneath the tray cable pulley, [Figure 3](#).

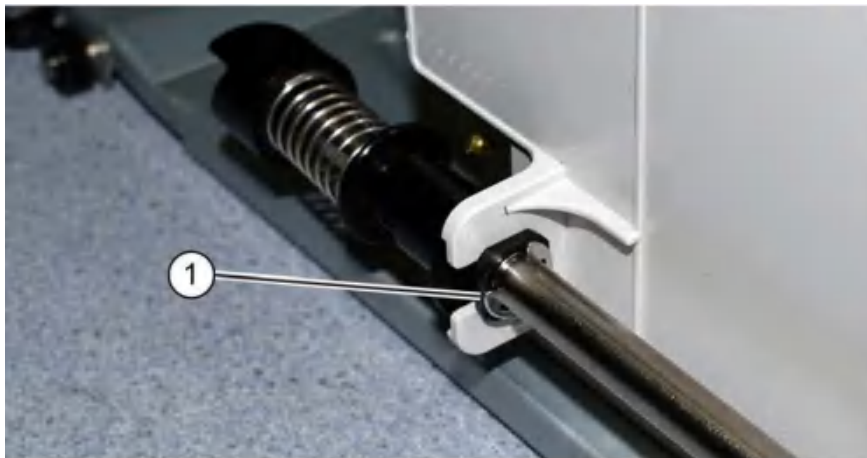
Figure 3 Rear E-clip

6. Remove the E-clip (1), [Figure 3](#):

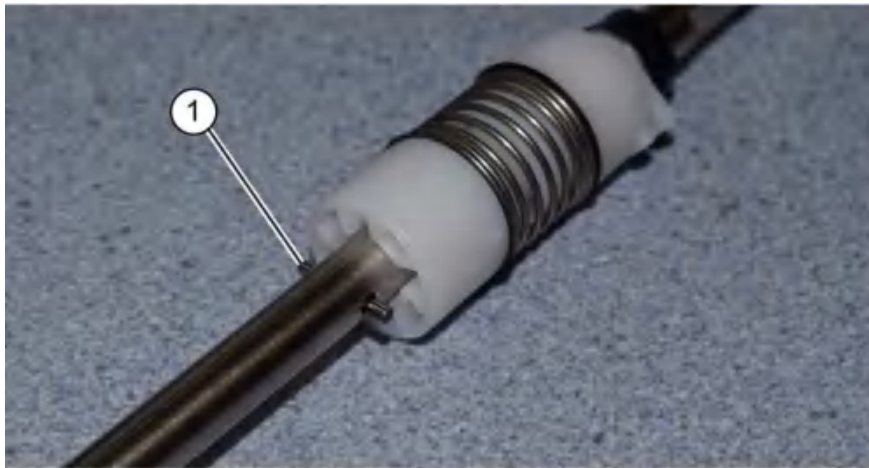
Figure 5 Pin

2. Ensure the brake securing pin (1) is installed correctly, [Figure 5](#).

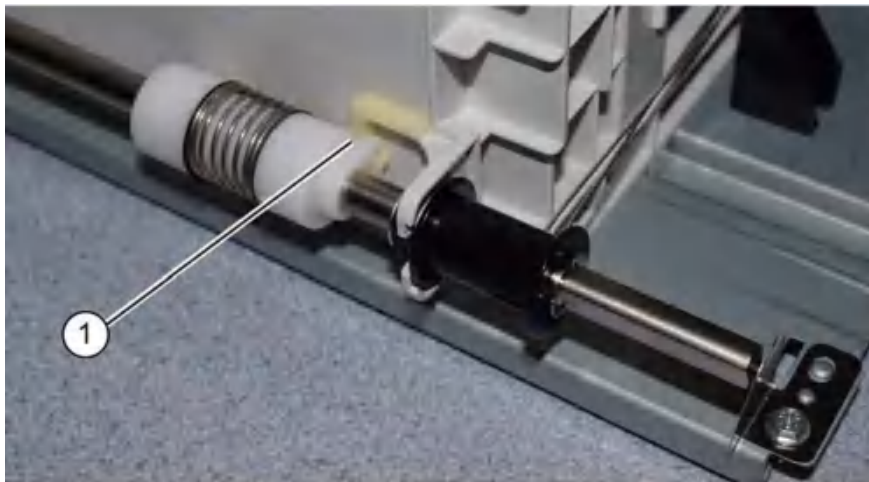
Figure 6 Brake

3. Ensure the brake (1) is correctly positioned against the tray frame, [Figure 6](#).

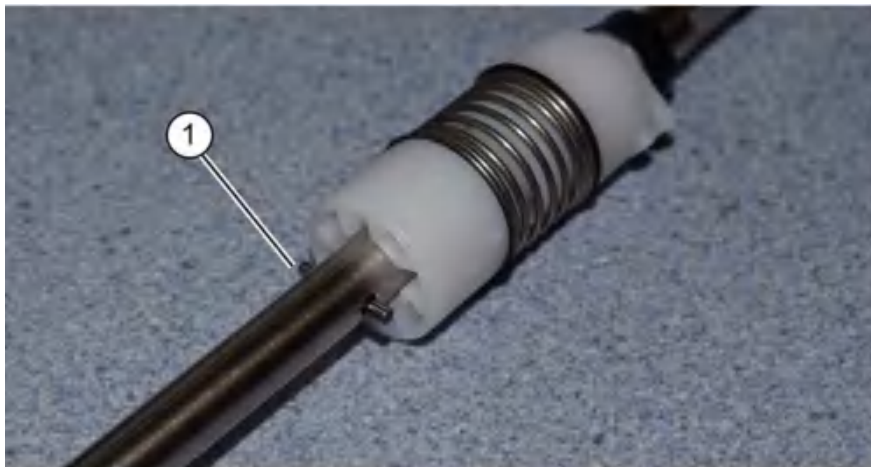
Figure 5 Pin

2. Ensure the brake securing pin (1) is installed correctly, Figure 5.

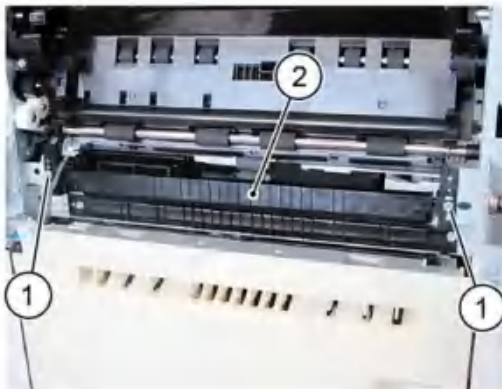
Figure 5 Tray 1 feeder assembly removal

8. Remove the tray 1 feeder assembly, Figure 5:
  - a. Remove two screws (1).
  - b. Remove the tray 1 feeder assembly (2).

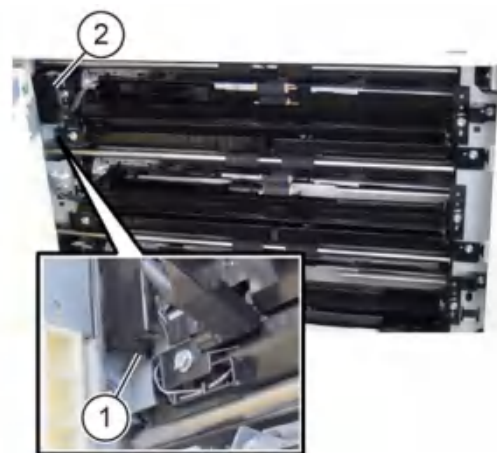
Figure 1 ESD cover removal

1. Pull out tray 2. Remove the paper.
2. Remove tray 2.
3. Open the left cover assembly, [PL 70.20 Item 11](#).
4. Remove the ESD cover, [Figure 1](#):
  - a. Disengage the hook (1).
  - b. Remove the ESD cover (2).

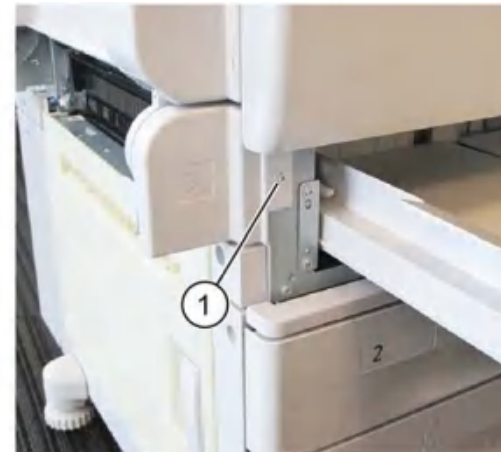
1. Remove the bypass tray, **REP 70.2**.
2. Pull out tray 1. Remove the screw (1) that secures the hinge front cover, **Figure 1**.

Figure 1 Hinge front cover

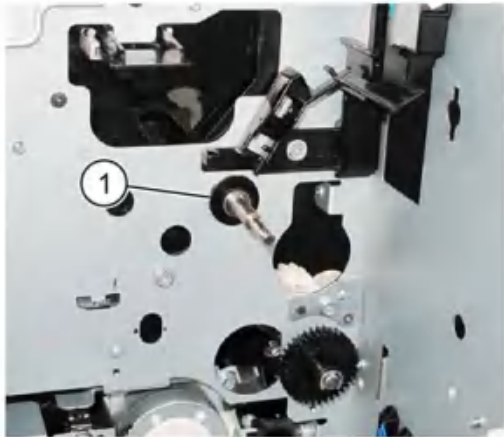
10. Remove the rear bearing, [Figure 3](#).

**Figure 3 Rear bearing removal**

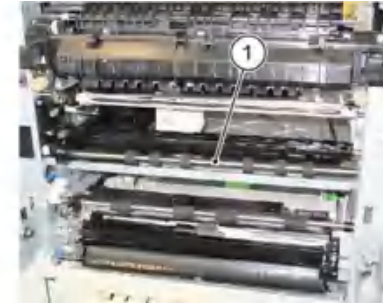
11. Remove the registration roll, [Figure 4](#).

**Figure 4 Registration roll removal**

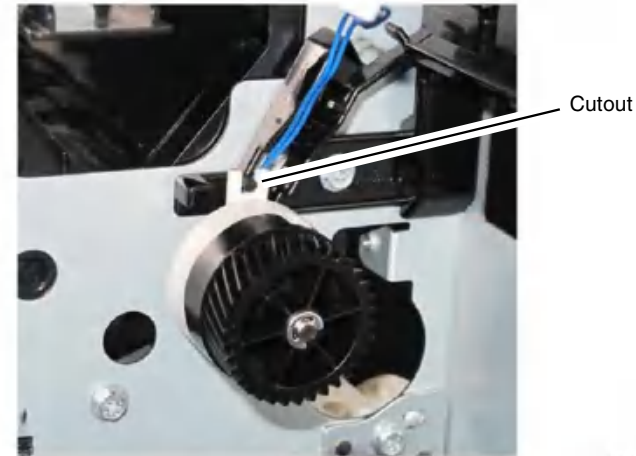
1. The replacement is the reverse of the removal procedure.
2. When installing the registration clutch assembly, align the cutout with the harness guide tab, [Figure 5](#).

**Figure 5 Alignment**

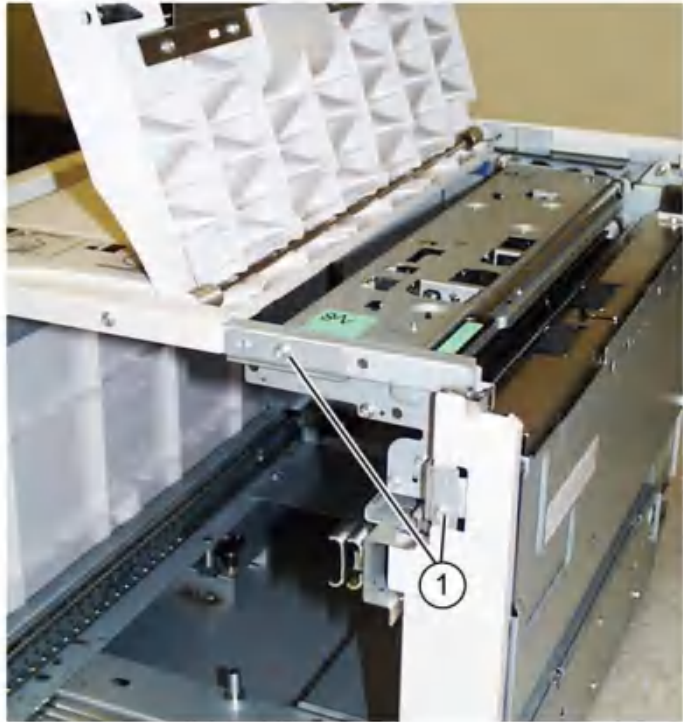
1. Move the HCF away from the machine.
2. Open the feeder top cover, [PL 70.55 Item 7](#).
3. Remove two screws (1) that secure the HCF feeder to the rail, [Figure 1](#).

Figure 1 Feeder securing screws

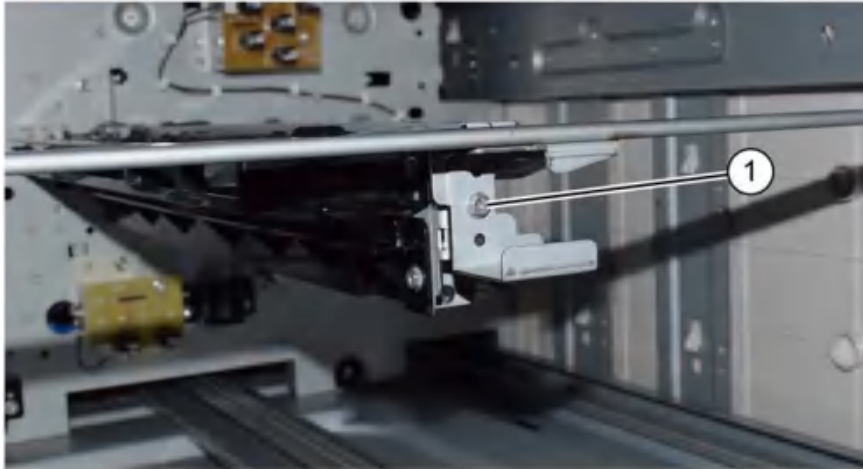
Y-1-0505-A

1. Pull out tray 2, 3 and 4. Remove the paper.
2. Lift out tray 3 and 4. Remove tray 2.
3. Remove the support bracket (1), [Figure 1](#).

Figure 1 Support bracket removal

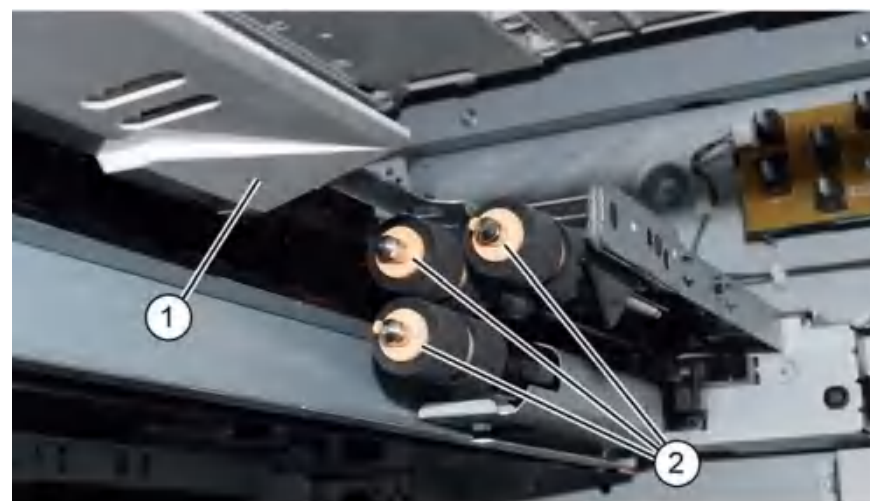
1. Pull out trays 2, 3 and 4. Remove the paper.
2. Remove trays 2, 3 and 4.
3. Open the left cover assembly, [PL 70.70 Item 7](#).
4. Remove the tray 4 feed, retard and nudger rolls, [Figure 1](#):
  - a. Slide the chute (1) forwards.
  - b. Release the clip, then remove the tray 4 feed, retard and nudger rolls (2).

Figure 1 Roll removal

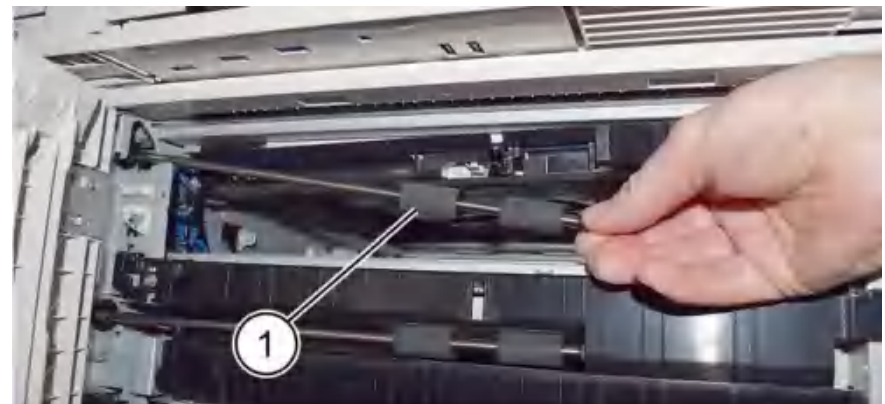
Y-1-0544-A

9. Remove the takeaway roll (1), [Figure 4](#).

Figure 4 Takeaway roll removal

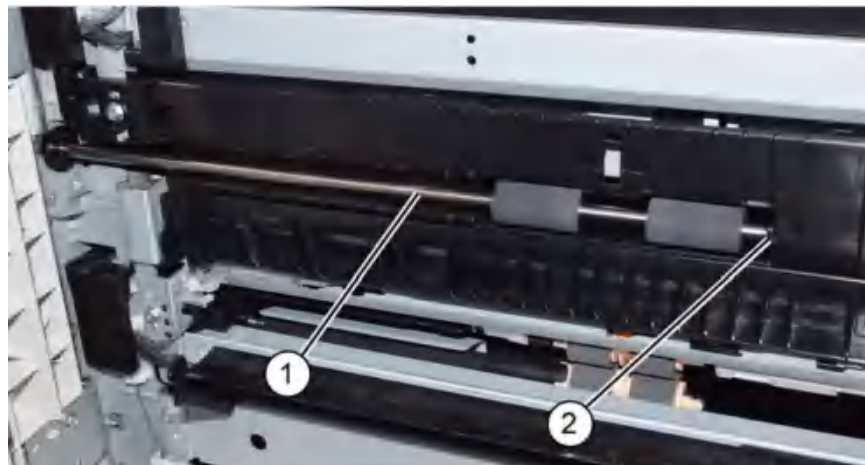
Y-1-0513-A

5. Remove the lower takeaway roll (1) and bearing (2), Figure 7.

Figure 7 Roll removal

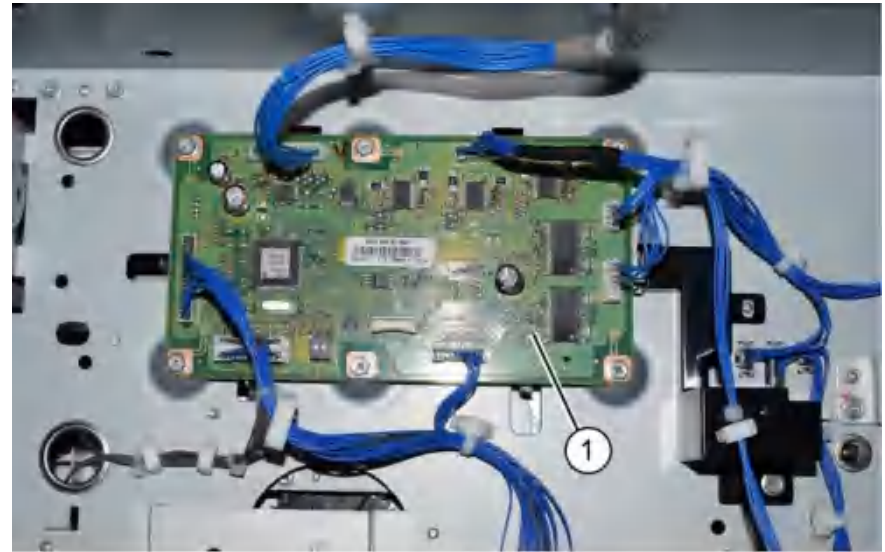
Y-1-0514-A

1. Remove the TTM rear cover, [PL 70.95 Item 8](#).
2. Remove the TTM PWB, [Figure 2](#):
  - a. Disconnect seven connectors.
  - b. Remove six screws.
  - c. Remove the TTM PWB (1).

Figure 2 TTM PWB removal

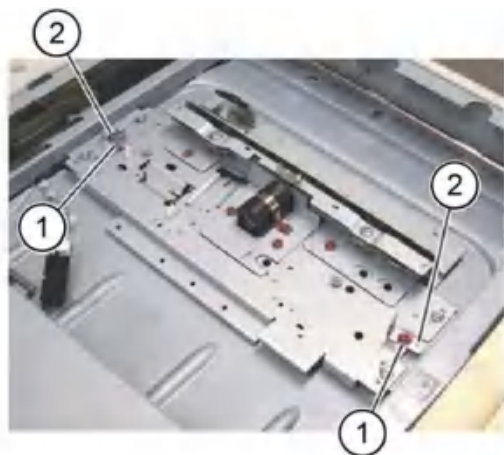
Figure 1 Alignment pins

3. Remove the alignment pins from the lens assembly, Figure 1:
  - a. Remove two screws (1).
  - b. Remove the alignment pins (2).

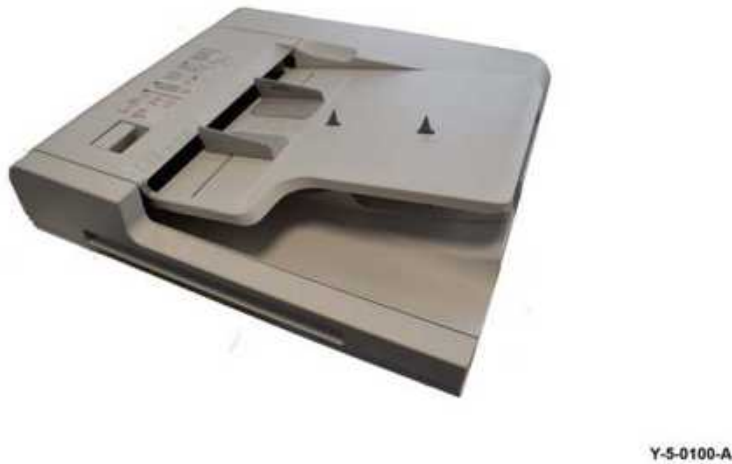
The DADF can invert a document to scan images on both sides, and it employs a constant velocity transport (CVT) system. With the CVT system, the lamp carriage of the IIT is fixed at a specified position (the scan position) where images are scanned as documents feed across the platen at a constant speed. Refer to [Figure 1](#).

**Figure 1 DADF**

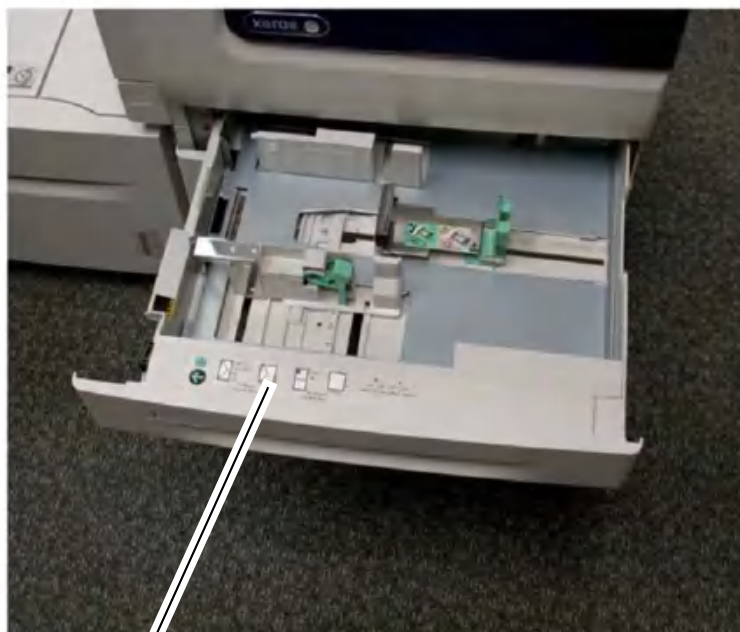
Envelope tray

An optional envelope tray is available, [PL 70.100 Item 1](#). The envelope tray is installed by the customer in the tray 1 position. Refer to [Figure 5](#).

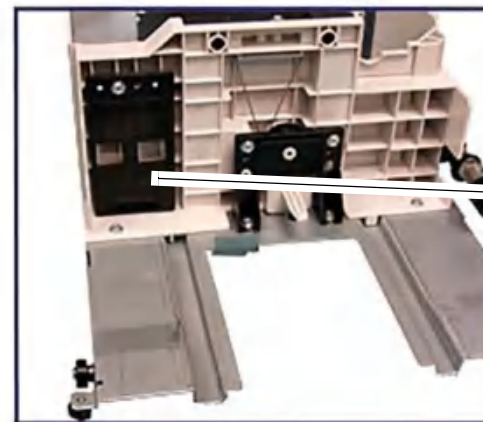
**Figure 13 Tray 3 paper size sensor actuator**

**Tray 3 paper size sensor** - The tray 3 paper size sensor detects if tray is inserted and senses paper size. The tray 3 paper size sensor contains two switches, [Figure 15](#). The size actuator, [PL 70.66 Item 2](#), mounted on the tray, that works with the tray side rear, [PL 70.66 Item 3](#), and the side front, [PL 70.66 Item 4](#), guides, presses these switches, [Figure 13](#). The combination of the on and off states of these switches changes the output voltage, based on which paper size is sensed.

For tray 3 and tray 4, the tray size sensor senses A4 LEF, Letter (8.5 x 11 inch) LEF, and B5 LEF paper.

The tray 3 size actuator is a thin, clear film sheet with cutouts; tray 4 is similar.

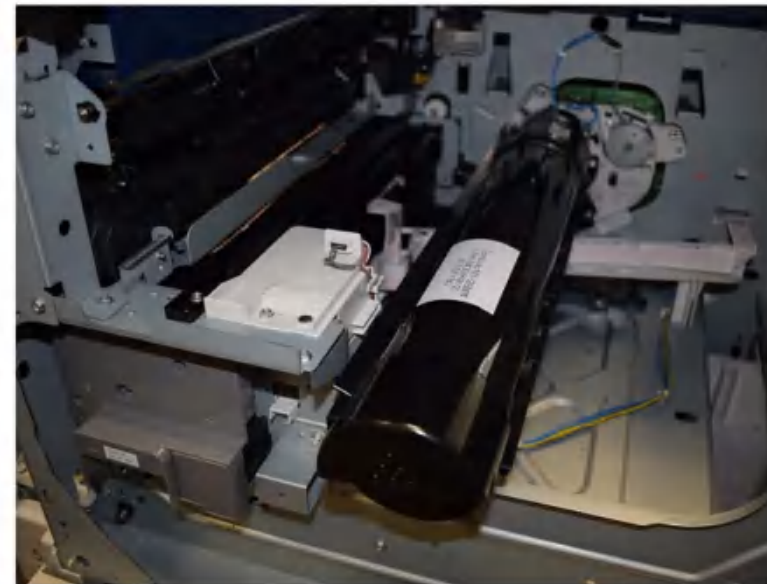
Y-5-0142-A

The print engine uses the following components in the xerographic process, refer to [Figure 1](#).

- Toner cartridge (customer replaceable unit).
- Toner dispenser assembly.
- Drum cartridge (customer replaceable unit).
- Laser Print Head (LPH).
- Bias Transfer Roller (BTR) (customer replaceable unit).
- HVPS.

**Figure 1 Main xerographic components**
