# **Xerox® VersaLink® B7025/B7030/B7035**

## **Multifunction Printer**

### **Service Manual**

708P91369

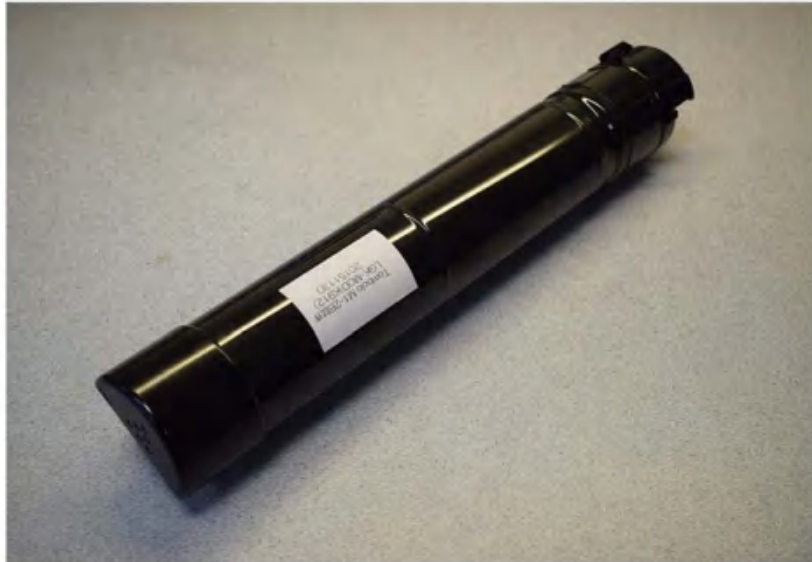
Y-5-0143-A

The toner cartridge is a customer replaceable unit (CRU) with sufficient toner capacity for up to 31 000 pages. Refer to [Figure 2](#).

**Figure 2 Toner Cartridge**

- **Pre-Near End-of-Life:** the toner cartridge is approximately 25% full
- **Near End-of-Life:** the dispense motor is on but the ATC sensor detects no increase in toner in the drum cartridge.
- **End-of-Life:** the ATC sensor detects no toner in the drum cartridge. The machine hard stops at this point.

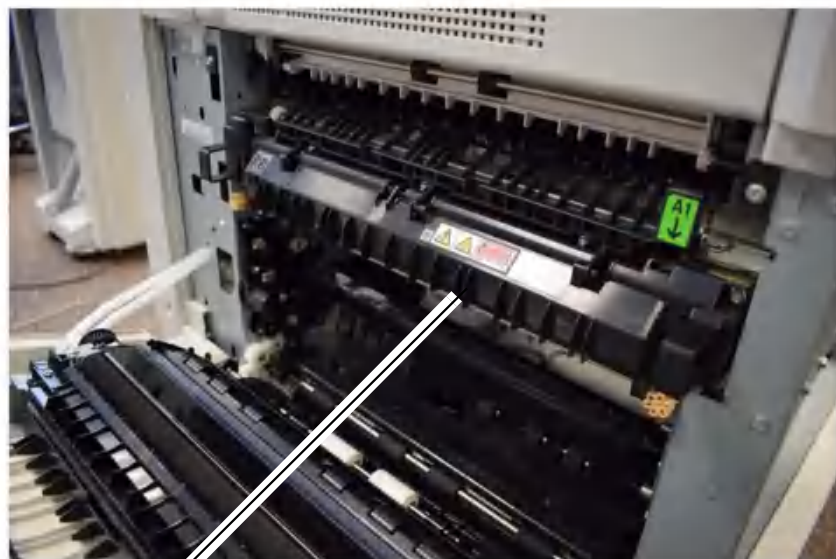
Y-5-0167-A

**NOTE:** There are no spare parts in the fuser assembly. The fuser is replaced as an assembly.

Fuser

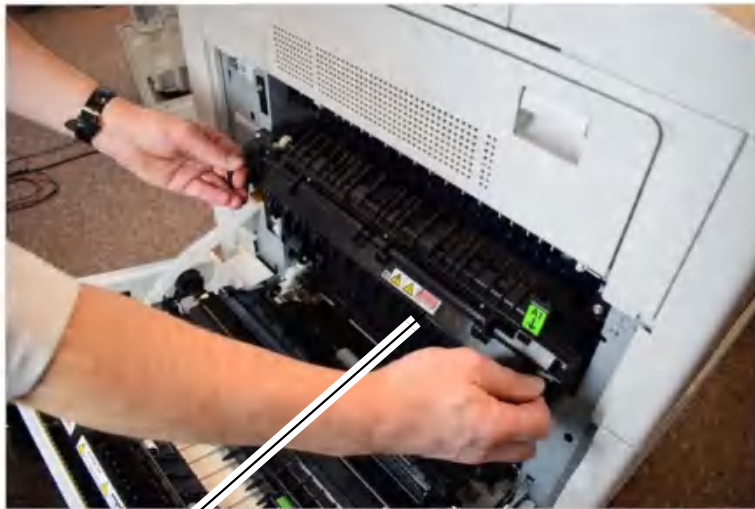
At power on after installing a new fuser a fuse is blown within the fuser module, this activates the resetting of the HFSI counters automatically.

Figure 6 Fuser replacement

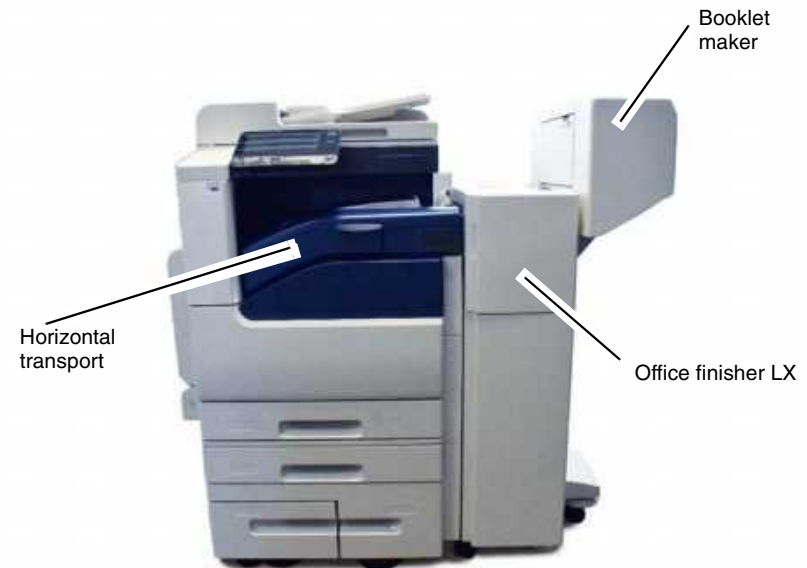
Y-5-0021-A

The finisher LX can collate, stack, staple, and hole punch up to 2000 sheets or 200 sets of 90gsm or 20lb paper. For paper sizes greater than A4 SEF, the maximum number of sets is limited to 100. Refer to [Figure 1](#).

**Figure 1 Overview**

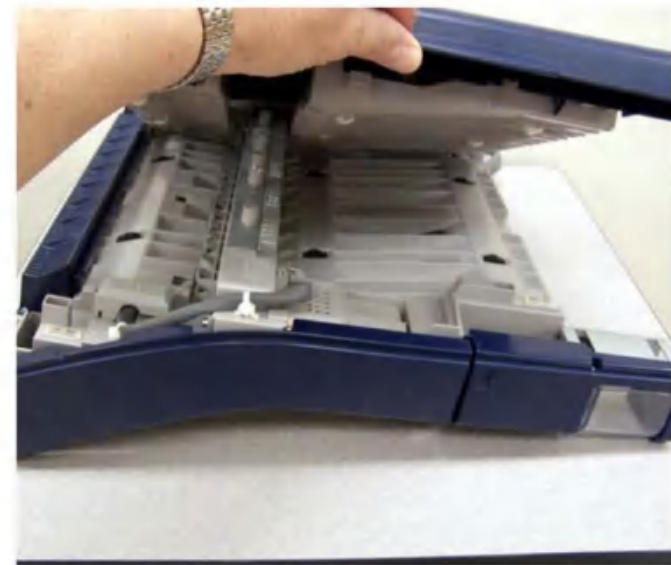
Y-5-0022-A

The horizontal transport assembly has its own drives, rollers, sensors, and interlocks and is powered and controlled by the finisher.

The top cover can be opened for jam clearance. Refer to [Figure 4](#).

**Figure 4 Horizontal transport assembly**

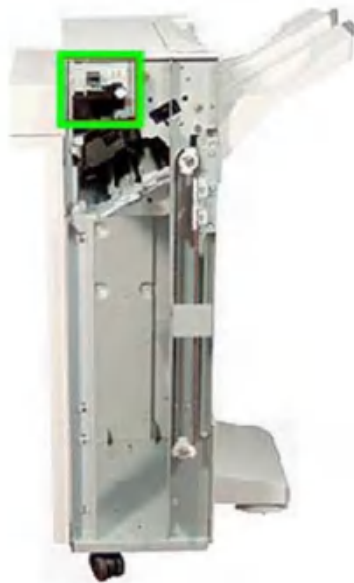
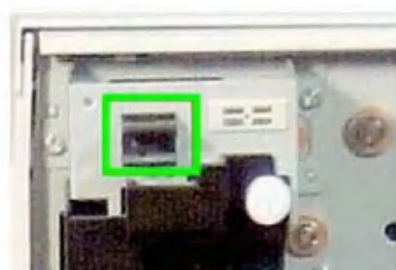
Y-5-0029-A

- **Eject Cover Switch** - triggered when the eject cover is raised. Refer to [Figure 10](#).
- **Front Door Interlock** - triggered when the front cover is opened. Refer to [Figure 11](#).

**Figure 11 Front door interlock**

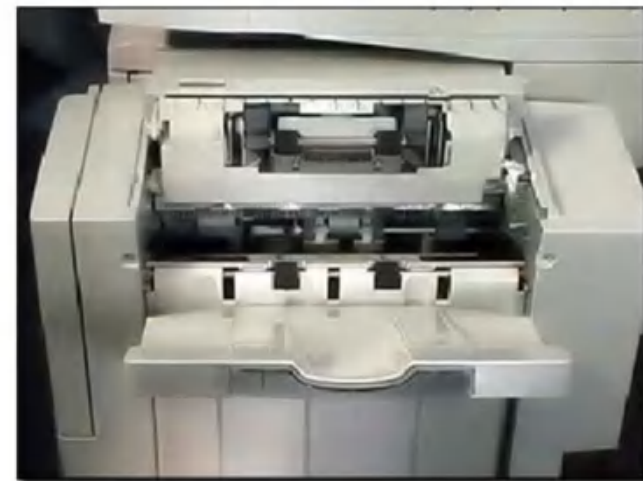
Y-5-0038-A

The rotation of the sub paddles actively drives the paper against the compiler backstops where the paper is tamped, stapled (if required), and ejected.

**Figure 20 Sub paddle assembly**

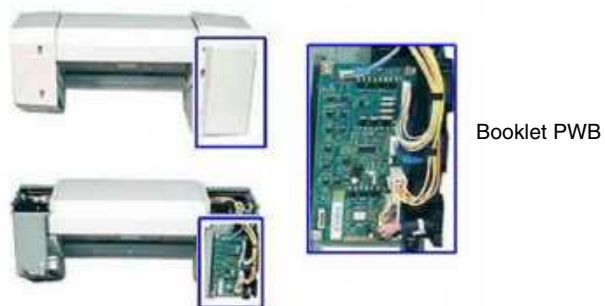
Y-5-0049-A

The booklet PWB controls all the booklet maker components and distributes the + 24V supply to the motors and + 5V to the sensors and interlocks.

The crease assembly is powered and controlled by the finisher PWB. Refer to [Figure 31](#).

**Figure 31 Booklet maker power and control**

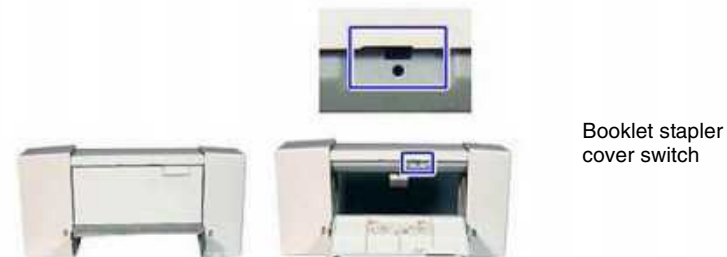
Y-5-0050-A

The booklet stapler cover switch is actuated when the side cover is opened. When actuated, all + 24V supplies are removed from the booklet maker. Refer to [Figure 32](#).

**Figure 32 Booklet stapler cover switch**

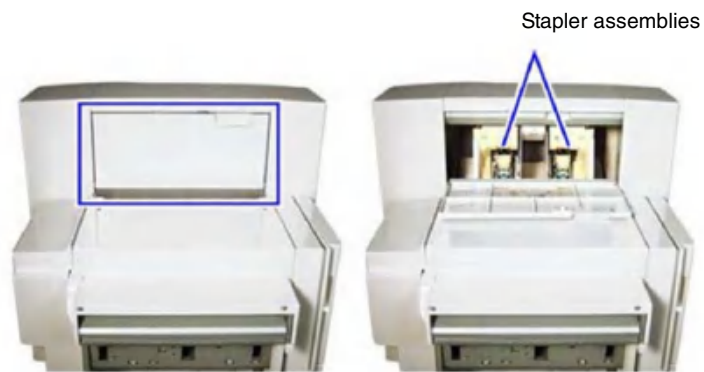
Y-5-0053-A

The booklet maker contains two staple assemblies which support and staple compiled booklets prior to ejecting into the stacker tray.

Each staple assembly contains a staple module and an exit sub chute. The staple units are mounted on a carriage rail. Refer to [Figure 35](#) and [Figure 36](#).

**Figure 35 Stapler assemblies**

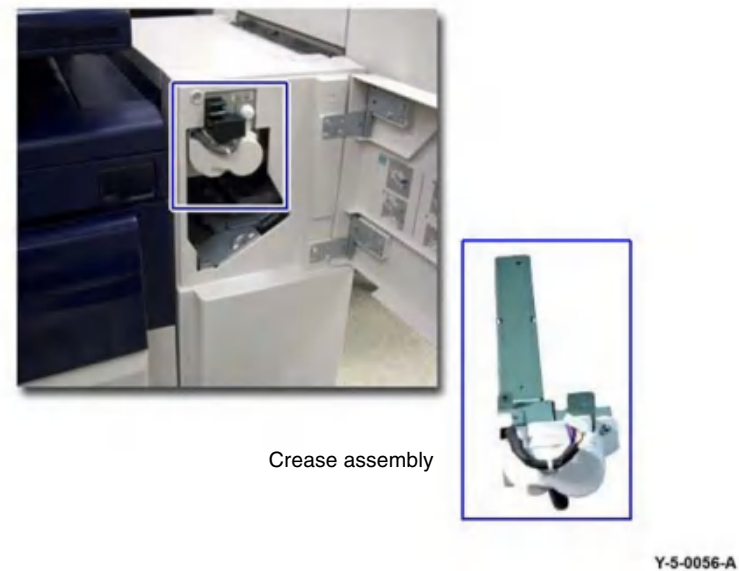
**Figure 38 Crease assembly**

It is installed behind the compiler within the Finisher LX and is controlled by the finisher PWB.

Refer to [Figure 38](#).

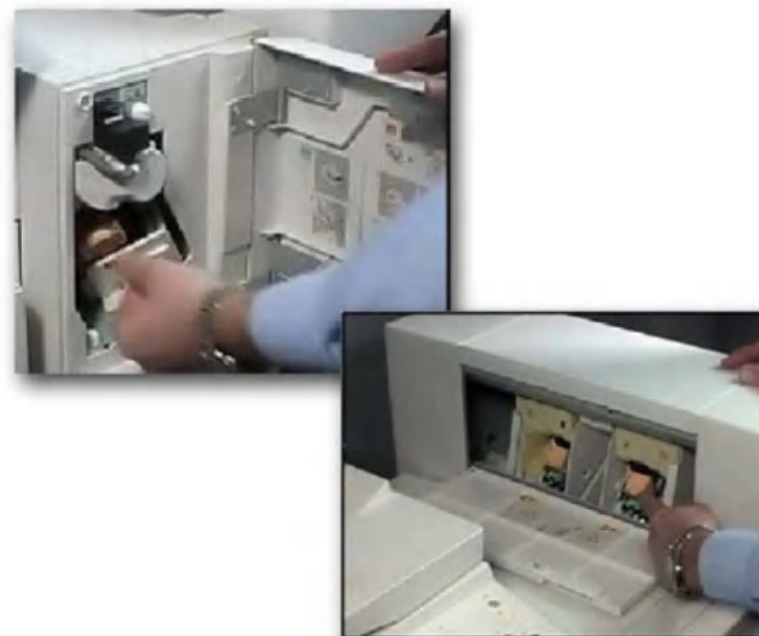
**Figure 49 Customer replaceable units**

Refer to [Figure 49](#). The only customer replaceable units (CRUs) for the LX finisher are:

- The 5,000 stitch staple cartridge and
- The two staple cassettes for the booklet maker. Each of the staple cassettes holds 2,000 staples.
